Earthquake Engineering

Categorisation | Review scientific paper

ENVIRONMENTAL IMPACT ASSESSMENT AND SEISMIC HAZARD ANALYSIS: PETRINJA 2020 EXPERIENCE

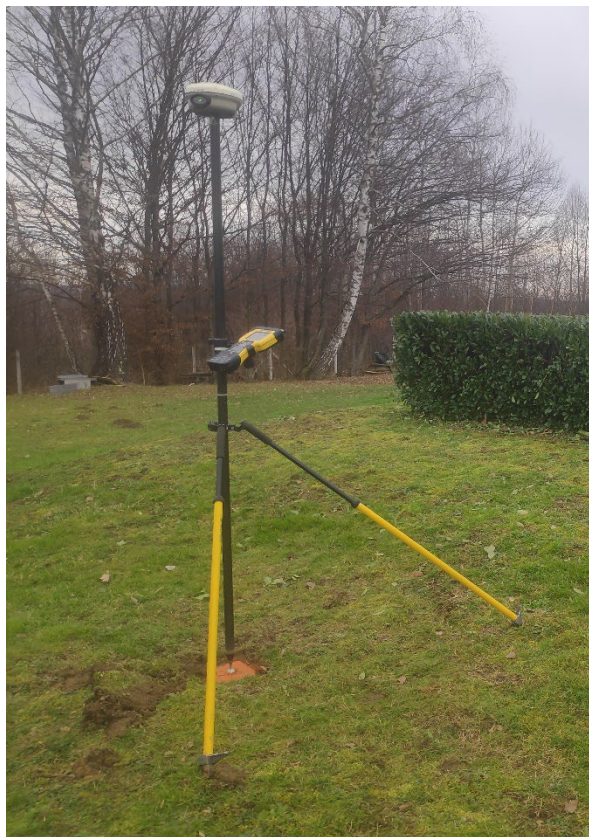
Figure 3: Geodetic benchmark post-seismic observation with GNSS receiver. Photo by authors.

Before the Petrinja earthquake sequence, benchmarks were established for cadastral and engineering purposes (2003–2020). They were remeasured just after the sequence (8 January 2021–13 March 2021) using a GNSS receiver and Croatian Positioning System (CROPOS), an online service for precise positioning. The geodetic benchmark kinematic measurements are accurate at the centimetre level, while the deformation values are at the level of a few decimetres. The largest displacement values resulting from the seismic activity were observed near the Petrinja centre, with a magnitude of 75 cm in the ESE direction. Sisak experienced planar displacements of approximately 7 cm to the east, while in Glina, the displacements were noted at around 6 cm in the NW direction. Notably, the most significant NW displacements, measuring 65 cm, were recorded in Strašnik, near the epicentre. This rich dataset allowed for the reconstruction of a dense displacement field related to the sequence and was therefore used to assess better the displacement field recorded after the event on 29 December 2020 and inform about the slip distribution on the earthquake source [8,9].

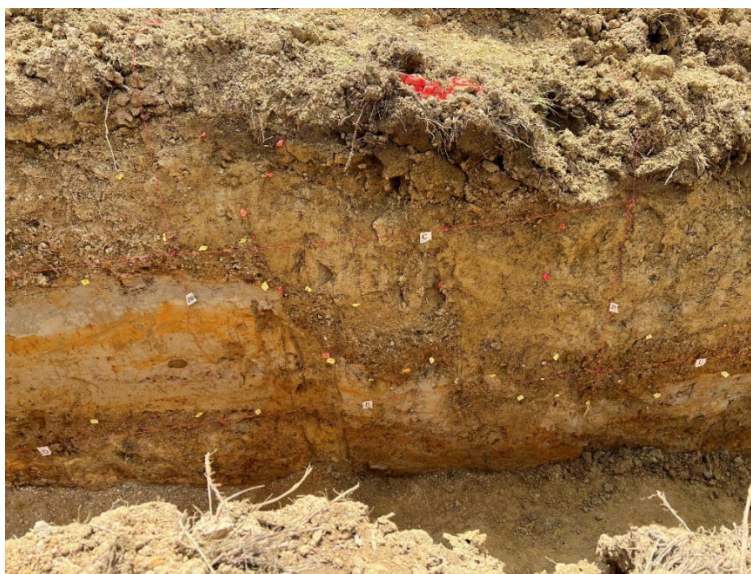
Figure 6: Detail of a trench wall dug across the northernmost section of the 2020 Petrinja surface rupture in Medurace. The section shows that a series of fault strands displaces the whitish to yellowish sands at the bottom (probably Pliocene to Miocene in age), together with overlying pebbles and silts (probably Pleistocene to Holocene) during successive faulting events. The height of the wall is ~2 meters. Photo by authors.
