АГГ+ часопис за архитектуру, грађевинарство, геодезију и сродне научне области
ACEG+ Journal for Architecture, Civil Engineering, Geodesy and other related scientific fields

DAYLIGHT PERFORMANCE
IN AN AUSTRO-
HUNGARIAN HERITAGE
BUILDING

The aim of this paper is to investigate the daylight performance in an Austro-Hungarian heritage building located in Banja Luka, Bosnia and Herzegovina. The building was originally used as a military headquarters and was later reused for administration and educational functions. The measurement of daylight was performed in a representative room-office in the building. The measurement results are discussed with respect to international standards and in relation to the specific architecture of the building. Furthermore, the simulation of the daylight performance was performed by using the Design Builder software.

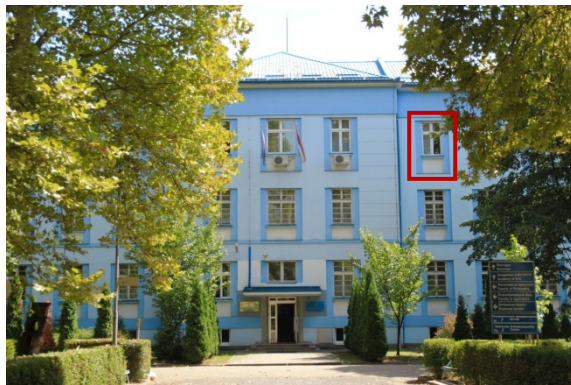
Figure 3. View of the western façade with the main entrance to the Rectorate building. The examined room is the uppermost right in the view, as indicated on the image.

The present-day Rectorate building (Figure 3) corresponds to a typical office or residential building from the early XX century built in countries with the Austro-Hungarian legacy – many similar buildings with the functions of convents, railway stations, schools etc. can be found around the former Empire, dated either during or shortly after the Austro-Hungarian era. It has a strongly emphasized longitudinal axis, oriented north-south, divided into five partitions: central and side Avant-Corps, all interconnected with side wings. In structure, it has a slightly elevated ground floor with two floors above, and a basement only below the central part and side wings. The main corridor is located on the eastern façade, with the office rooms on the west, facing the aforementioned tree alley, almost entirely flanking the façade and significantly obstructing the sunlight.

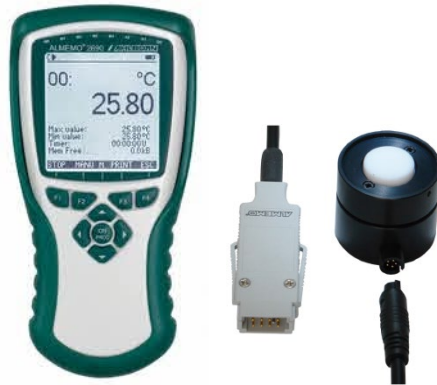
Figure 5. Almemo Ahlborn 2690-8 (left), luxmeter (right)

For the purpose of the illuminance measurement, which is performed according to the standard EN BAS 12464, the data logger Almemo Ahlborn 2690-8 and corresponding sensor-luxmeter were used (Figure 5). Technical specifications of the instrument are: the illuminance measurement range (0 lx to 260.000 lx), accuracy $\pm 5\%$ (optional $< 3\%$) and spectral correction.
